Confidential Inspection Report

LOCATED AT:
123 ABC Dr.
East Stroudsburg, Pennsylvania 18301

INSPECTED ON:
Thursday, December 17, 2021

Inspector, Michael Manter
Manter Inspection Company

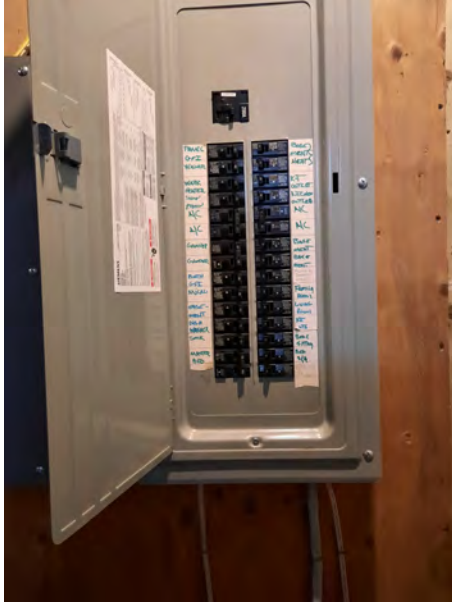
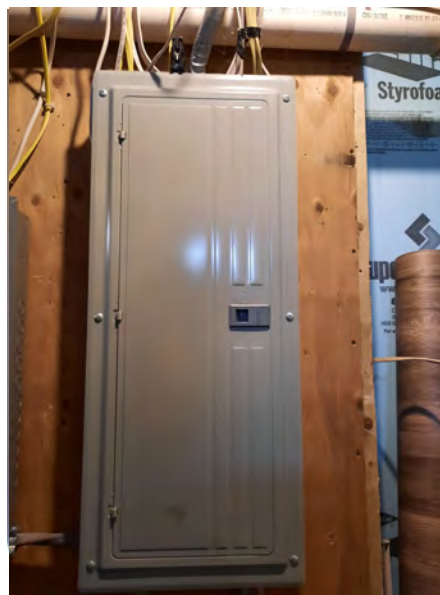
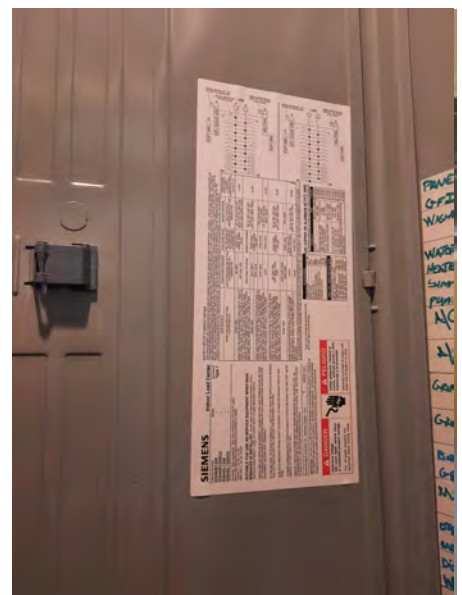
CB MAIN PANEL

FPE, Zinsco, Sylvania, Bulldog, Stab-lok, etc. panels and/or breakers have a long history of performance and safety issues. Because one of these panels was seen during our inspection, we recommend further evaluation by an electrical contractor.

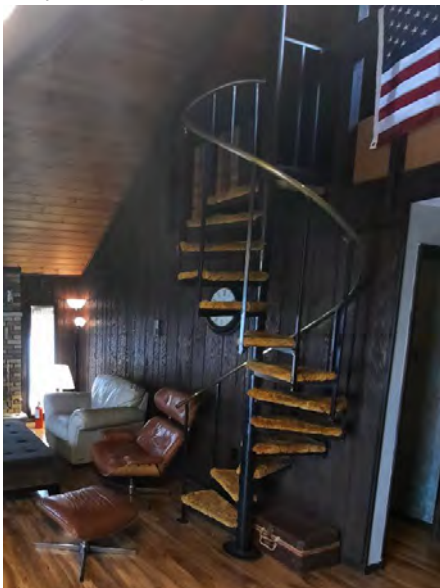
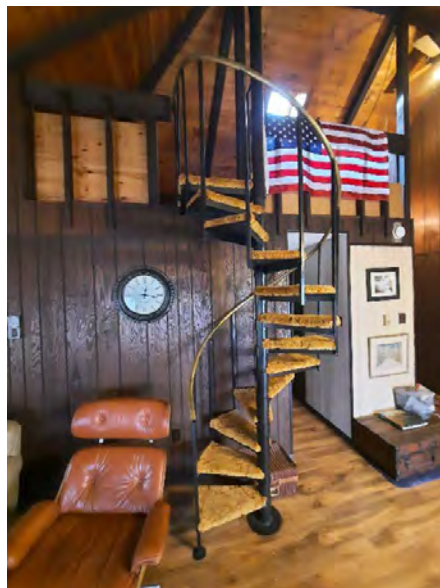
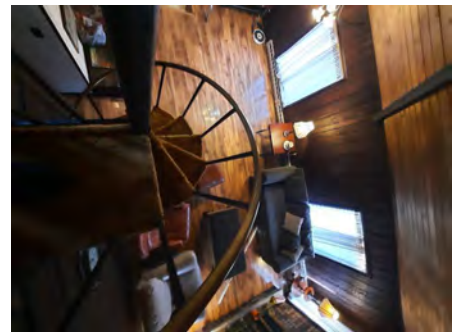
STAIRS

The spiral stairs are nonconforming. Ideally, the stairs should be modified for maximum safety, but this may be impractical. Recommend further review.

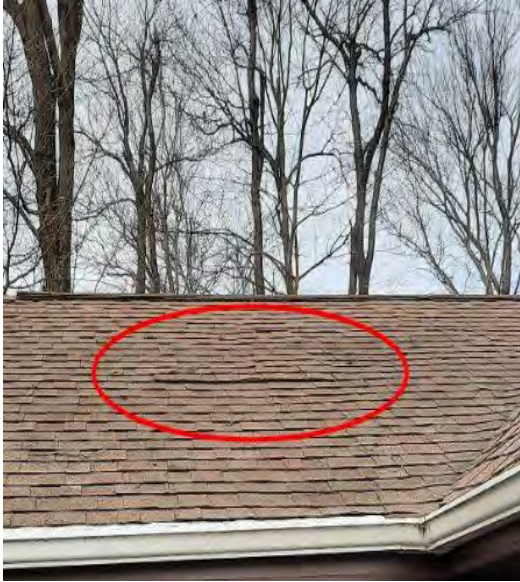
SURFACE

WARN There are shingles that have curled due to prolonged exposure to the elements and aging. This is generally only an aesthetic issue, but this is an indication of advanced age.

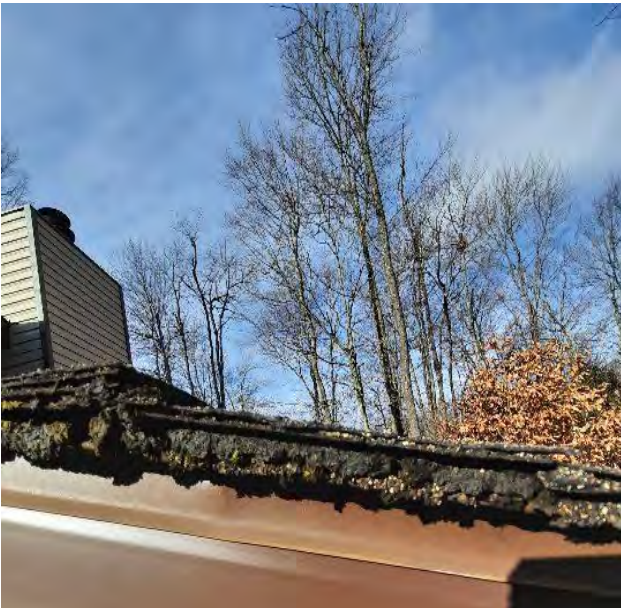
GENERAL COMMENT

The roof is weathered and has been patched, an appropriate short term solution. The roof should be reviewed periodically for indications of further deterioration and additional repairs performed as needed.

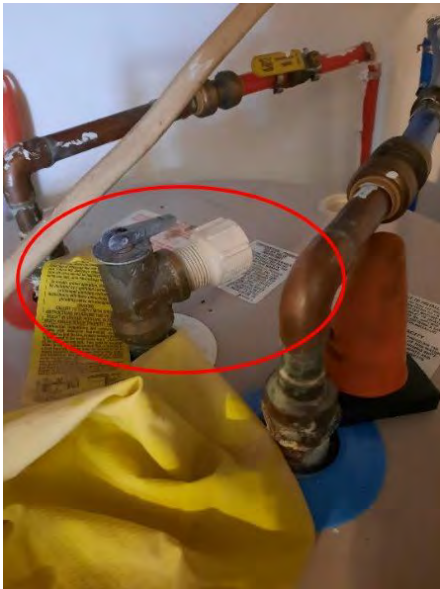
T/P RELEASE VALVE

The temperature and pressure relief valve lacks a discharge pipe. We recommend the installation of approved piping to an approved location.

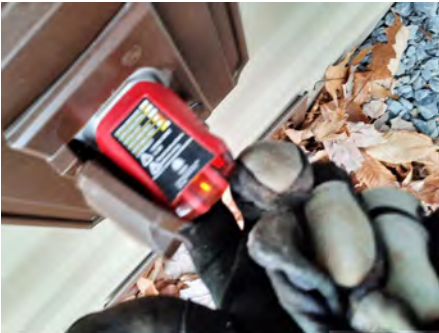
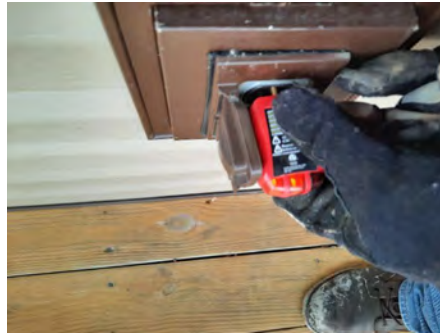
OUTDOOR RECEPTACLES

GFCI protection was not found where this feature is now required. We recommend GFCI protection be installed.

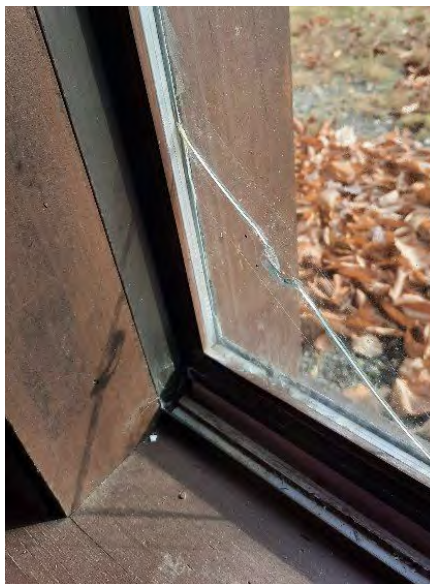
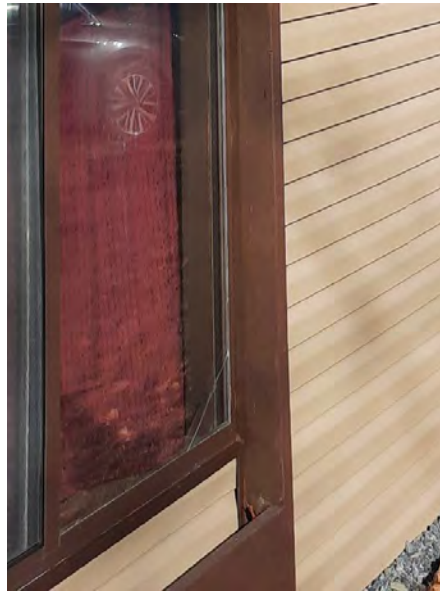
WINDOWS

Several windows are damaged. We recommend they be repaired or replaced.

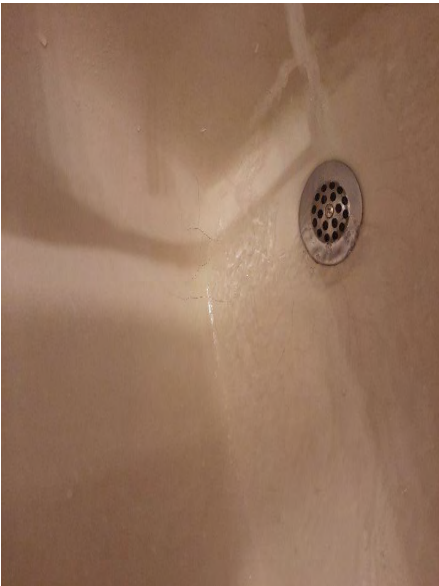
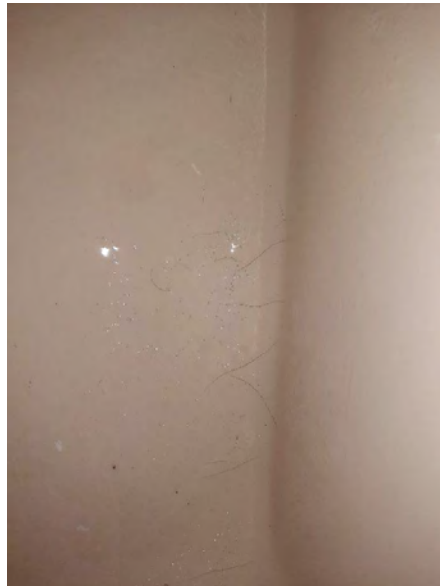
BATHTUB

The bathtub is damaged. We recommend it be repaired or replaced.

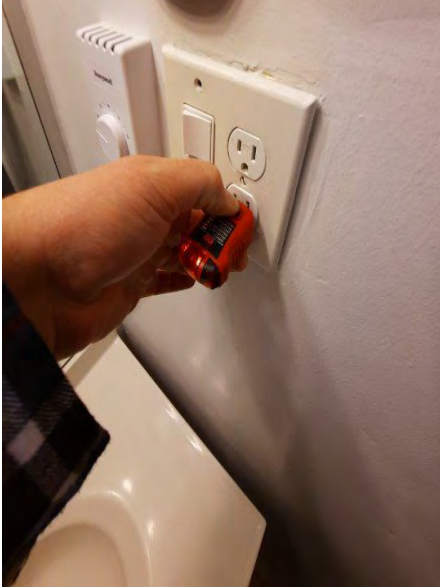
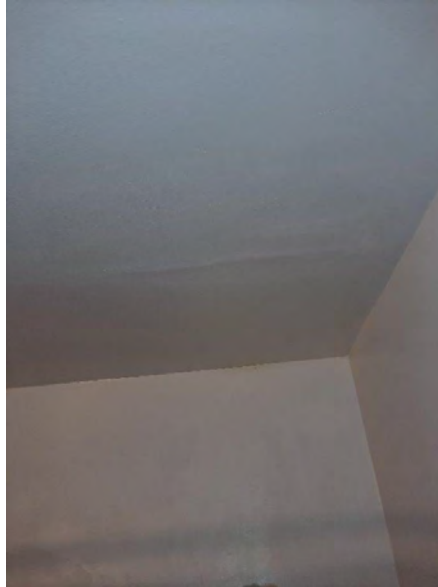
RECEPTACLES

There is no GFCI (ground fault circuit interrupter) protection for this bathroom. For an increased margin of safety, we recommend the installation of a GFCI receptacle.

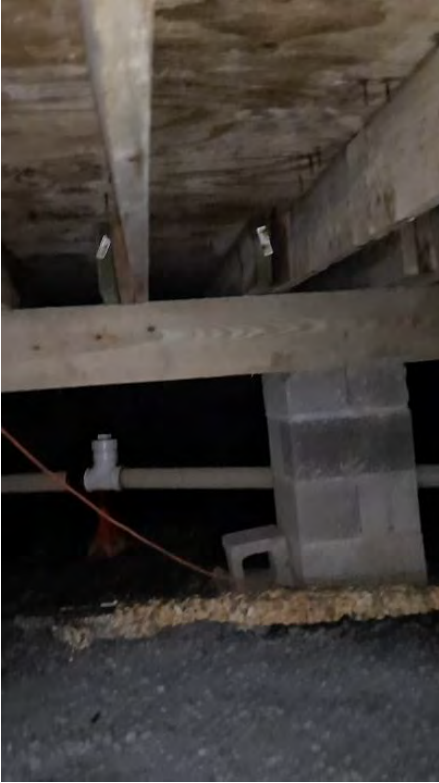
SUBFLOORING

WARN The subflooring is in good condition. However, the subflooring was wet at the time of this inspection. No damage was apparent. However, we recommend that the source of the moisture be found and eliminated before damage develops.

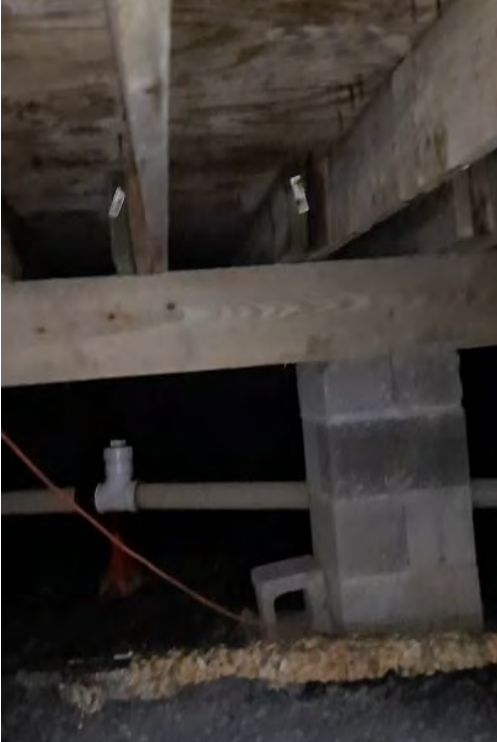
VAPOR BARRIER

WARN There is no vapor barrier in place in this crawl space. A vapor barrier is considered a beneficial feature and we recommend one be installed.

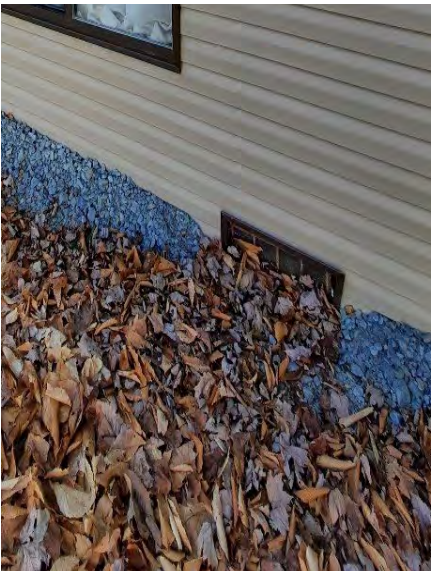
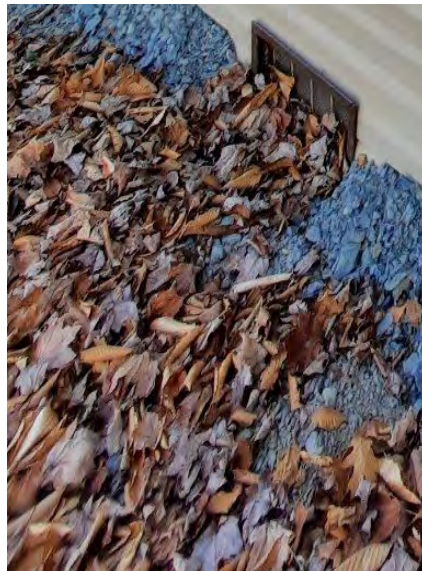
VENTILATION

WARN Vents are blocked from the inside and outside. We recommend they be cleared to allow proper ventilation of the crawl space.

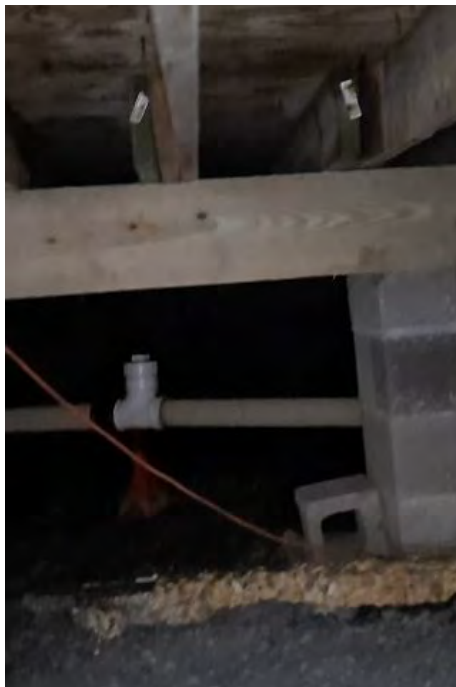
FLOOR INSULATION

UPG There is no insulation beneath the floors, which is a common finding in older homes. While optional, upgrading would reduce cold air infiltration and make the home more comfortable.

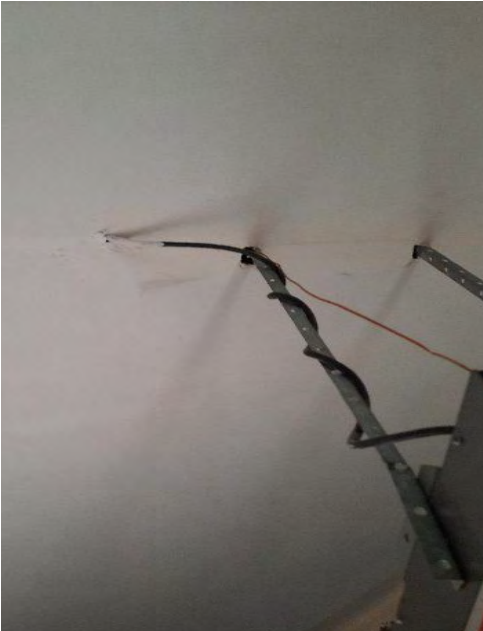
WIRING

Many signs of non-original workmanship were noted in this inspection. A licensed electrician should review the entire system and verify compliance with present industry standards.

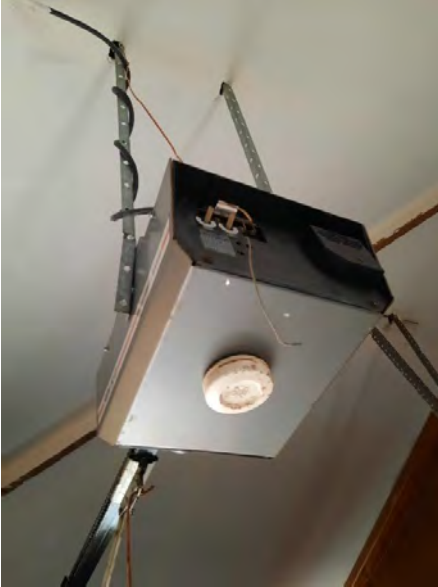
GARAGE DOOR OPENER

WARN The garage door opener raises and lowers the door, but it does not stop or reverse when it meets resistance prior to full closure. This is an important safety feature. We recommend the mechanism be repaired or replaced.

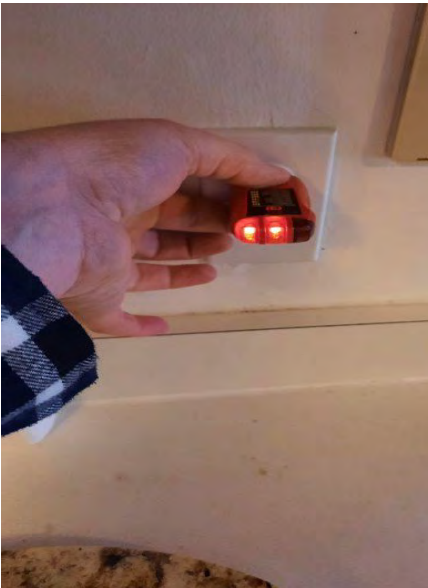
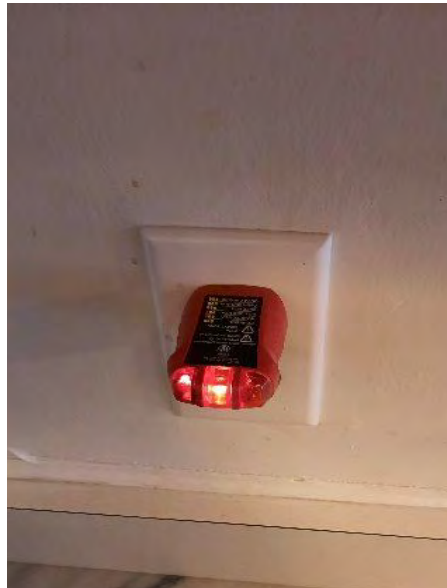
RECEPTACLES

There is no GFCI (ground fault circuit interrupter) protection for the countertop receptacle(s) within six feet of the sink. For an increased margin of safety, we recommend the installation of a GFCI receptacle(s).
